EPA-340/1-81-002
February 1981

Stationary Source Enforcement Series

An Investigation of Corrosion in Particulate Control Equipment

Thomas E. Mappes, Project Manager,
and Robin D. Tems, PH.D.
PEDCo Environmental, Inc.
Cincinnati, Ohio 45246

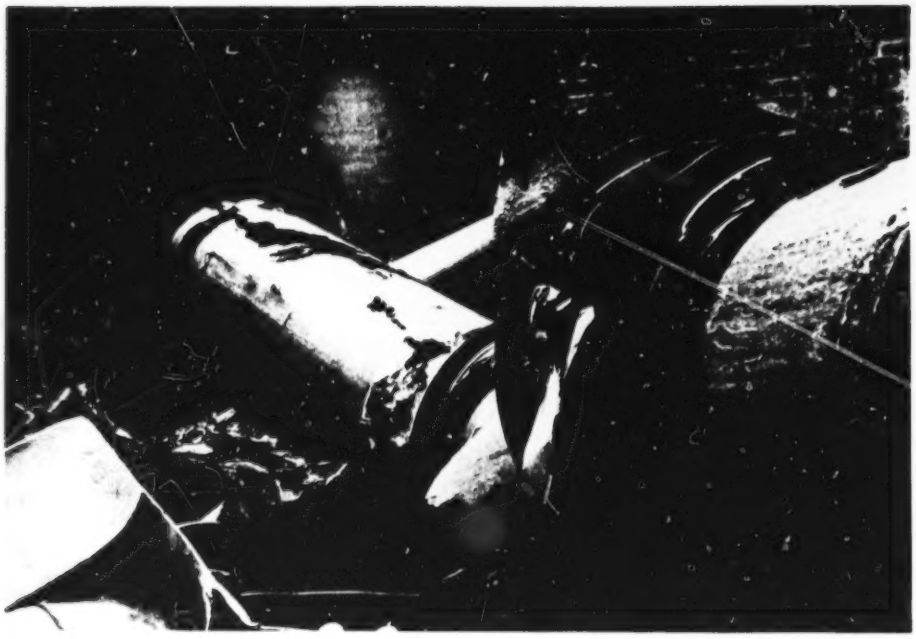
Figure 1. Wire-burning incinerator scrubber that was totally destroyed by corrosion.

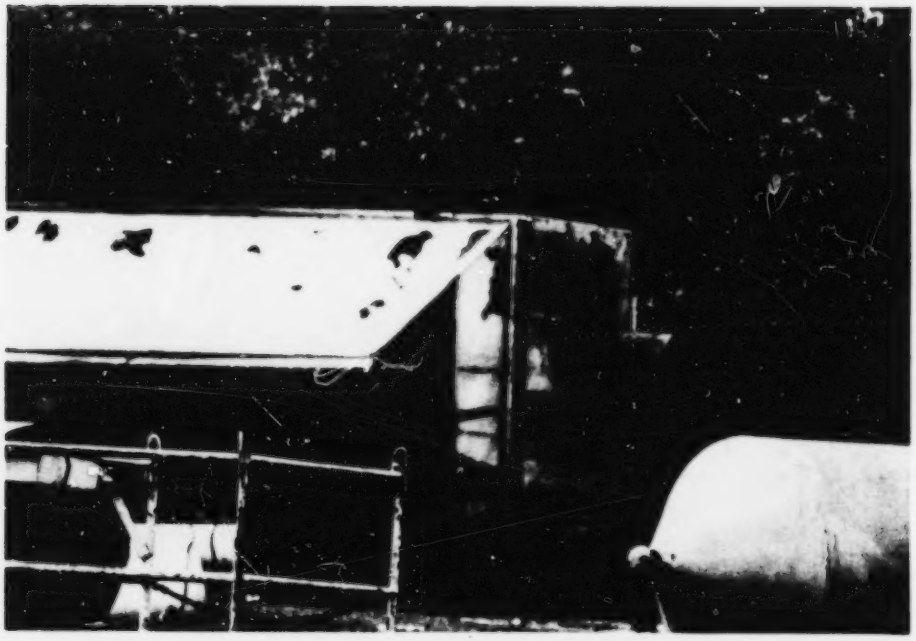
Figure 3. Cast iron cupola fabric filter that was scrapped after 5 years of service because of corrosion.

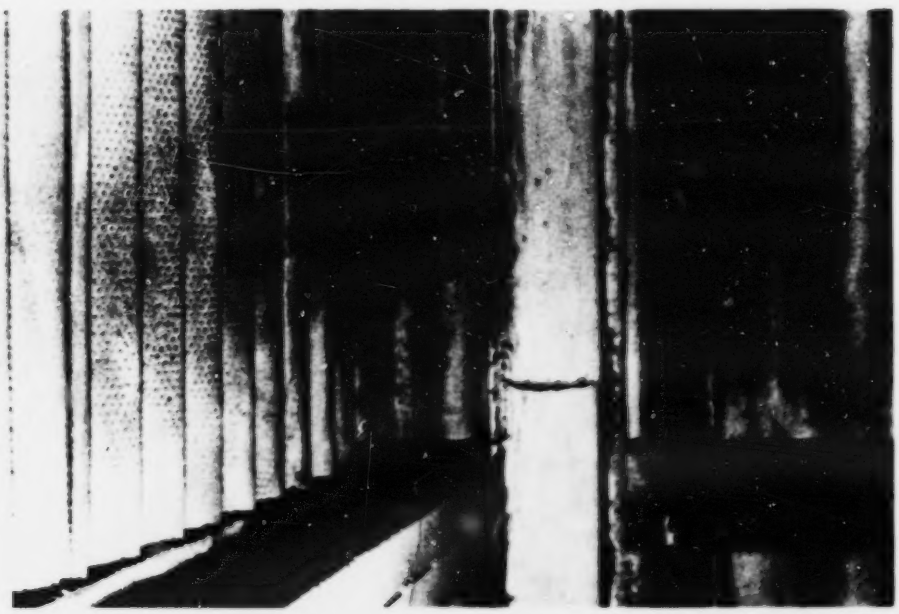
Figure 4. Corner of a fabric filter (from inside) showing corrosion of mild steel structure. Note that new horizontal beams have been welded to existing beams to reinforce corroded beams.

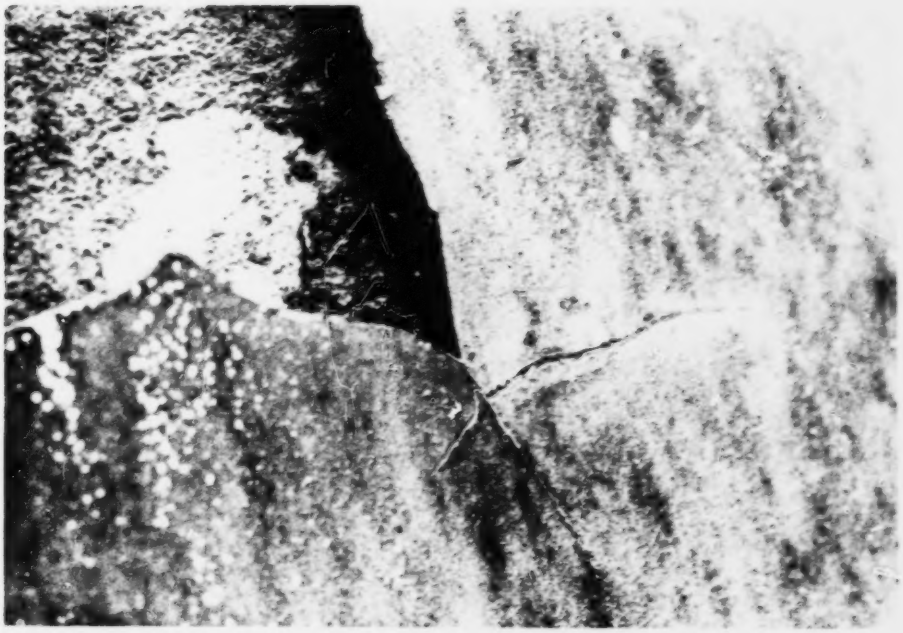
Figure 7. Stress corrosion cracking of stainless steel ductwork of a sewage sludge incinerator scrubber.

Figure 8. Weld decay in stainless steel ductwork of a sewage sludge incinerator scrubber; outleakage has caused additional corrosion on the exterior surfaces.

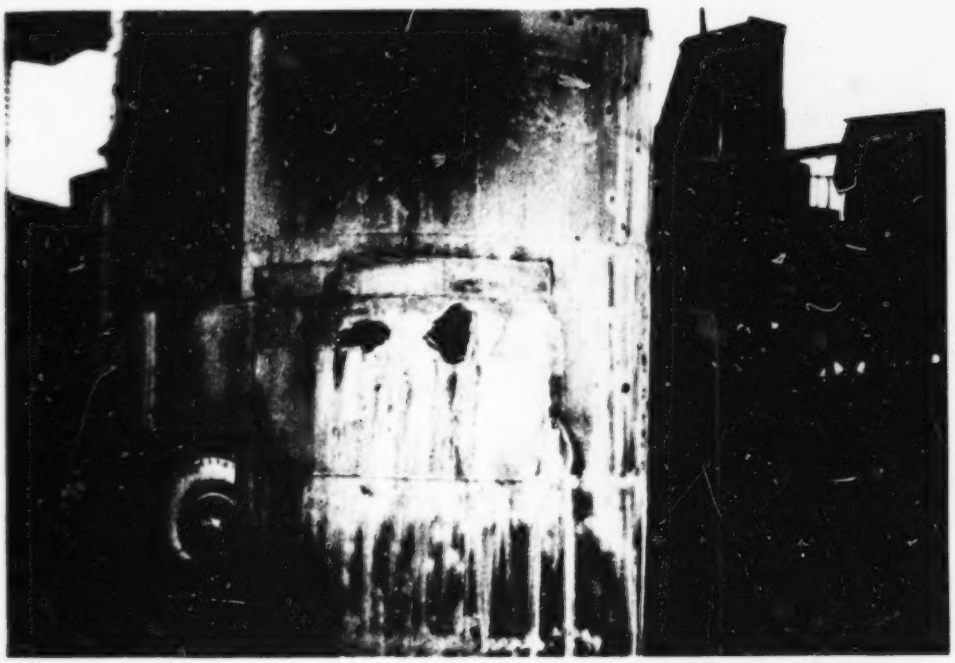
Figure 9. Erosion-corrosion at the inlet of a cyclonic mist eliminator of a venturi scrubber serving a hot-mix asphalt plant.

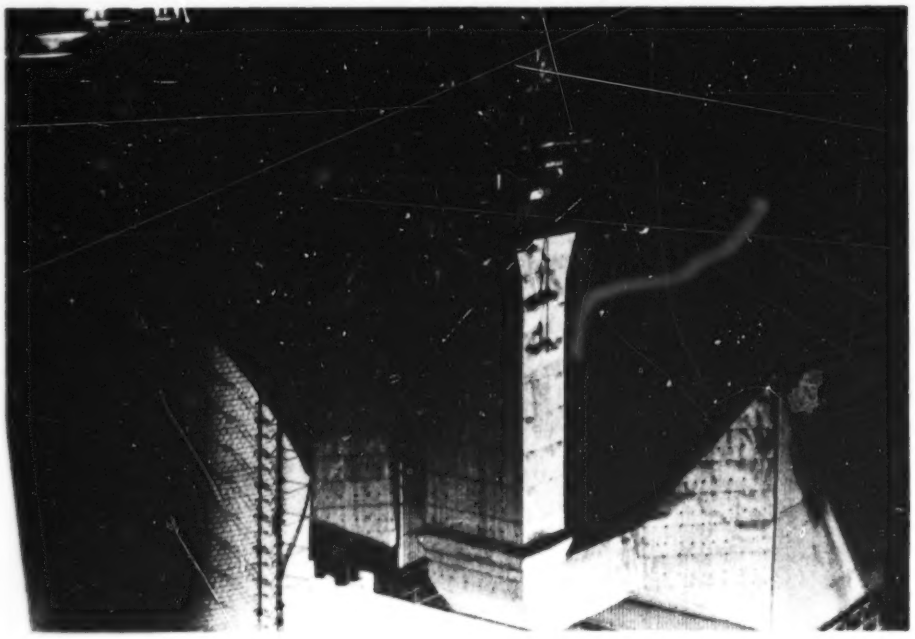
Insulation will be most effective if a few simple guidelines are followed.[11] Any insulation must be thick enough to sufficiently impede the flow of heat through the external surfaces of the control device. The insulation must also cover all exposed surfaces including the dust hoppers, access doors, and the ductwork. The insulation must be installed in such a manner that it will remain intact over the life of the equipment. Most types of insulation should have a protective sheath (usually sheet metal) on the outside to repell rainwater and to prevent mechanical damage. An insulation blanket should be sealed at the top and bottom to prevent a "chimney effect" circulation of outside air through or underneath the blanket. An example of a properly insulated electrostatic precipitator is shown in Figure 11.

Figure 11. Electrostatic precipitator with a complete blanket of insulation covering the chambers, hoppers, and ductwork.

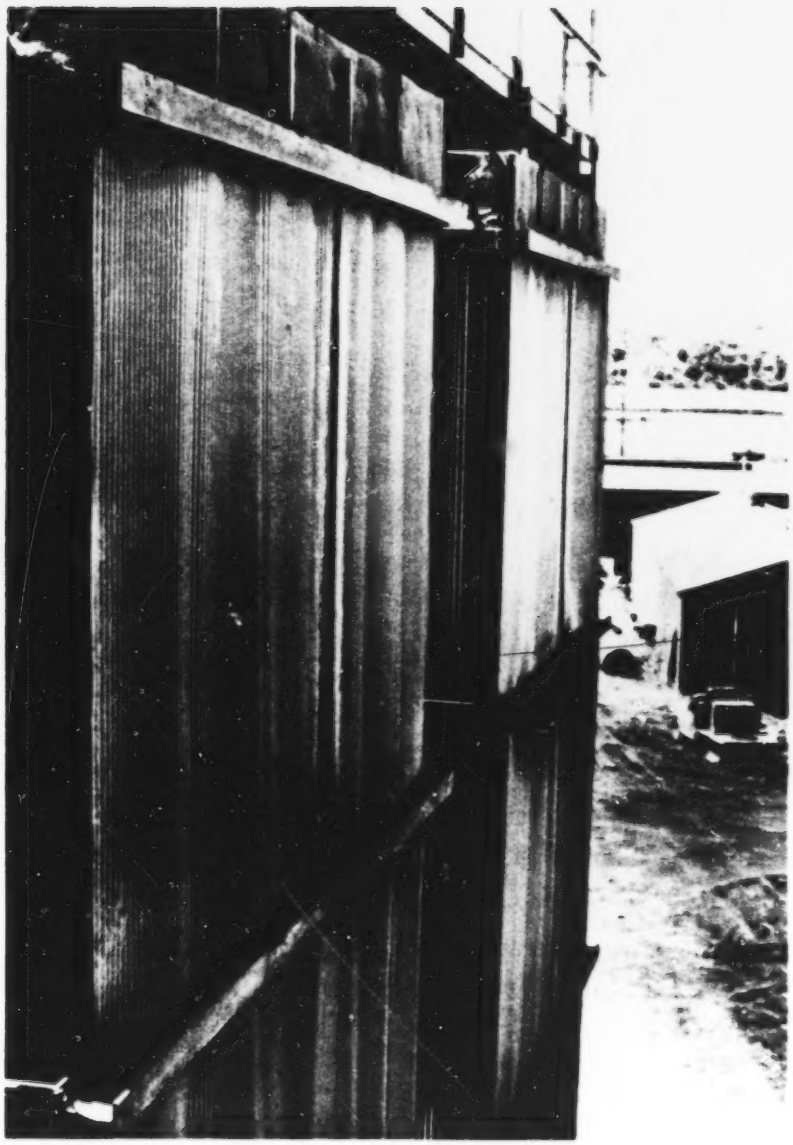
Figure 12. Insulated fabric filter with structural steel protruding through the insulation.

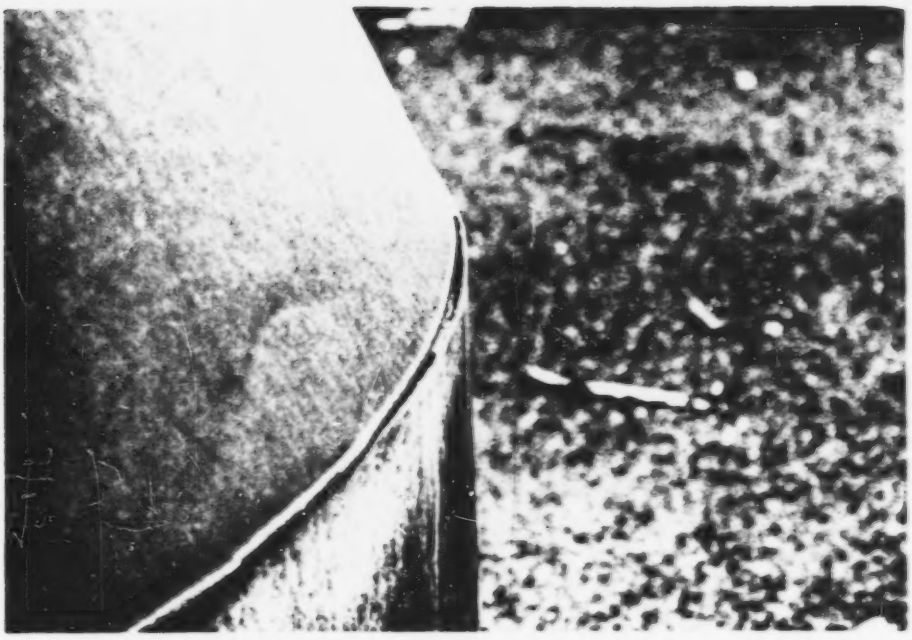
Figure 13. Gap in the sheathing covering an insulated duct.

Figure 14. Cracked vibration sleeve in ductwork, which allows air inleakage into the system.

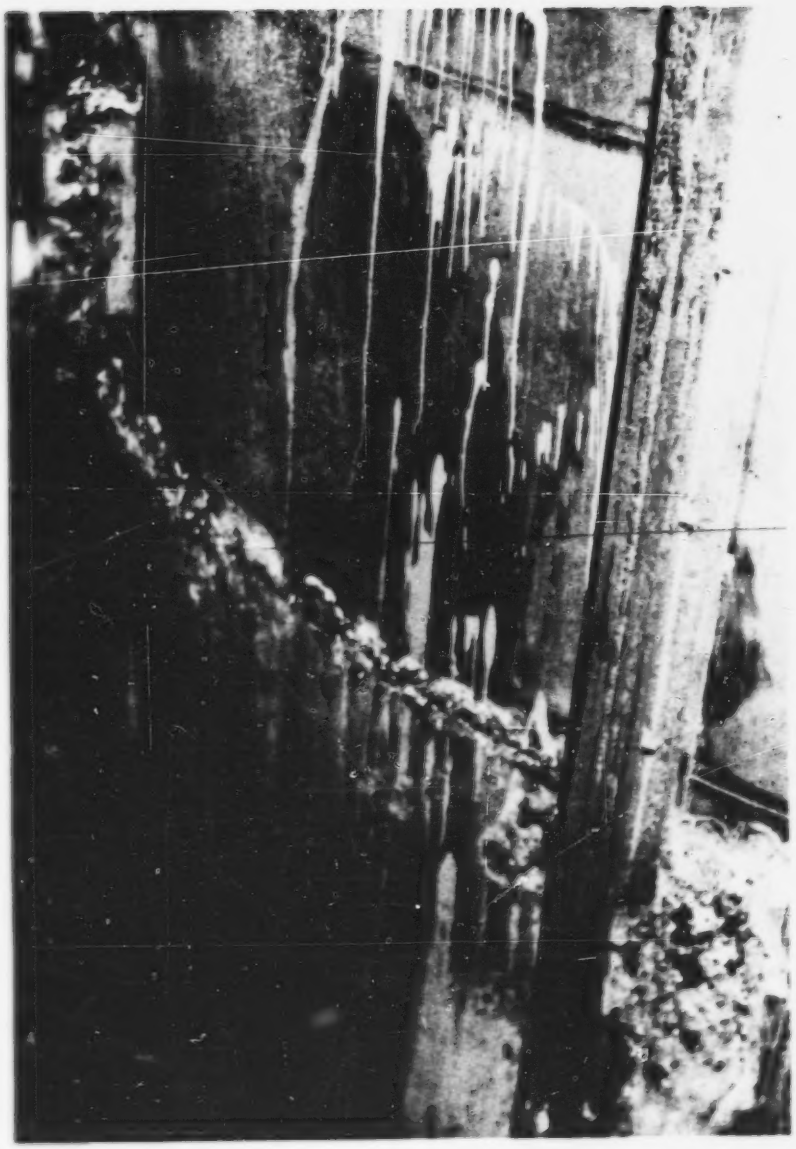
Figure A1-2. Salt deposits at corrosion leaks in the scrubber vessel. The corrosion appears to be structurally dependent, possibly affected by the internal configuration of the scrubber.

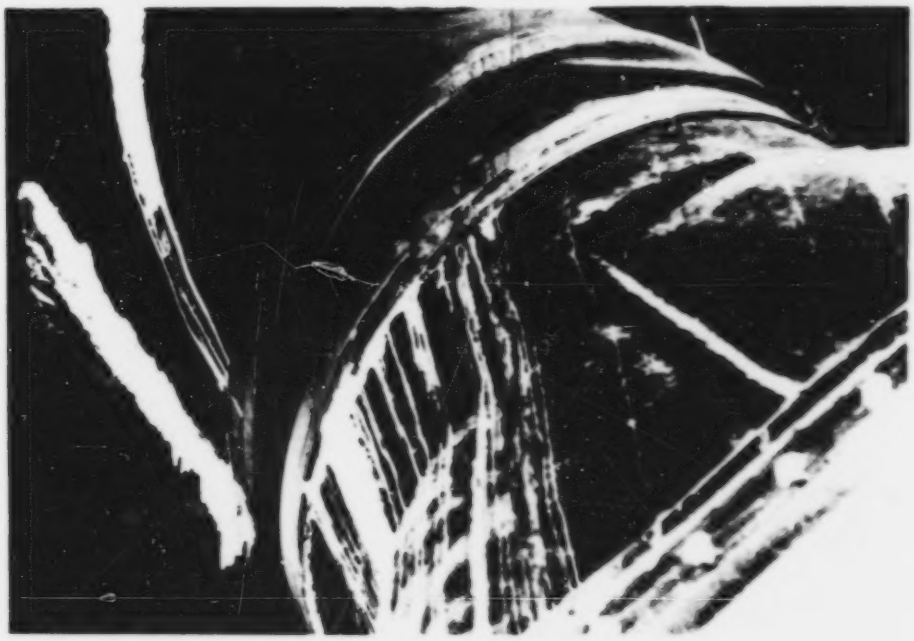
sometimes in the hot dry (bypass) mode and sometimes in the warm wet (scrubber) mode. The original stacks were fabricated from Inconel 600; these required patching during their 3-year life. In 1973, the original single stack on each incinerator was replaced with a dual stack system. A hot dry (bypass) stack was constructed from mild steel lined with refractory brick, and a warm wet (scrubber) stack was constructed from FRP. The stacks are currently holding up well, though there is some leakage at joints in the FRP stacks (Figure A1-4).

Figure A1-4. Leaks in fiberglass-reinforced plastic ductwork leading to the stack.

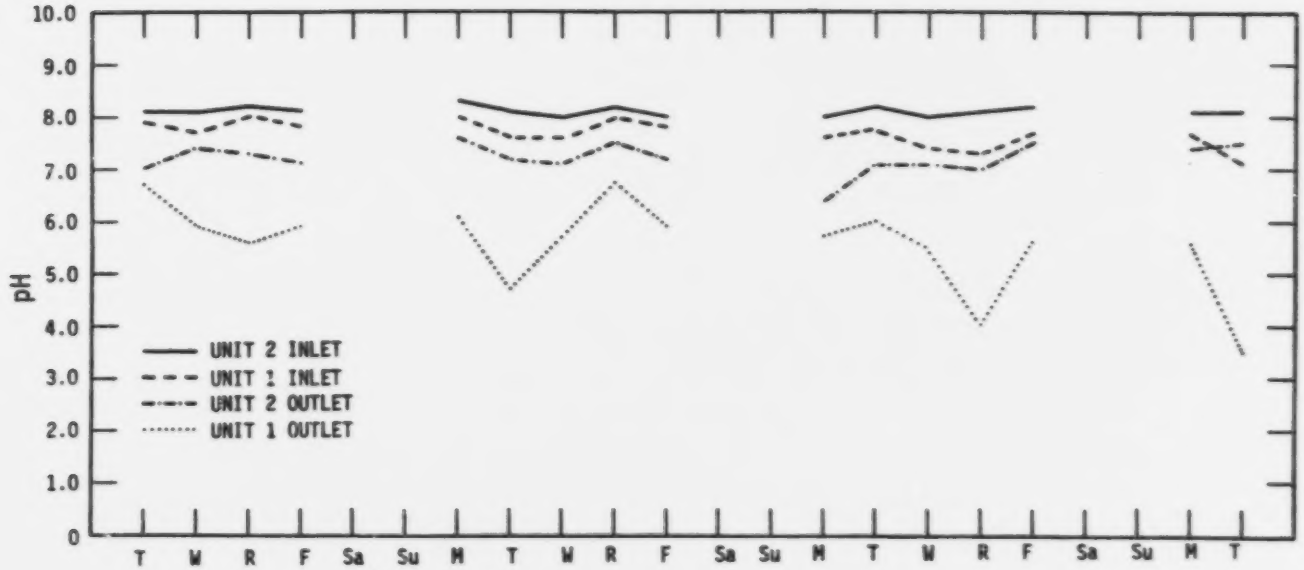
The pH control system was initially installed as a fully instrumented automatic system that used ammonia to control acidity. The plant, however, had continual problems with probes scaling and breaking. Thus, although the actual electronics worked well, the plant went to a once a day grab sampling method to avoid the probe problems. This method has led to some fluctuations in the pH of the recirculating water (Figure A1-5) because of the slow response time and because of the fact that

Figure A1-5. Variations in scrubber liquor pH over a 22-day period as measured in lab from daily grab samples (Mondays through Fridays).

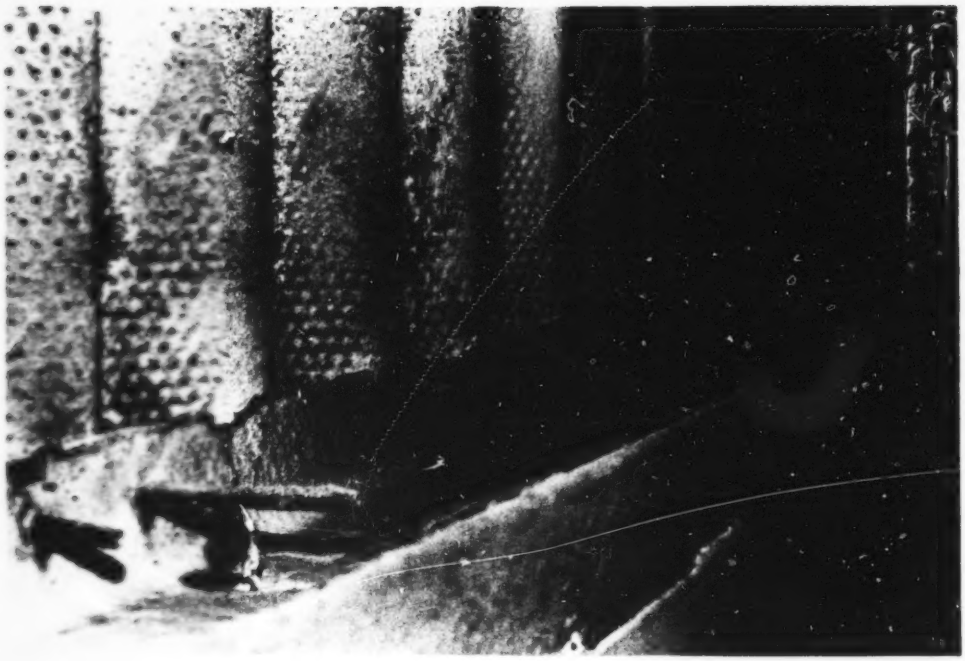
Figure A7-2. Closeup of Source 7 fabric filter cross-member showing that dewpoint corrosion is more severe along surfaces nearest the cool outer wall.

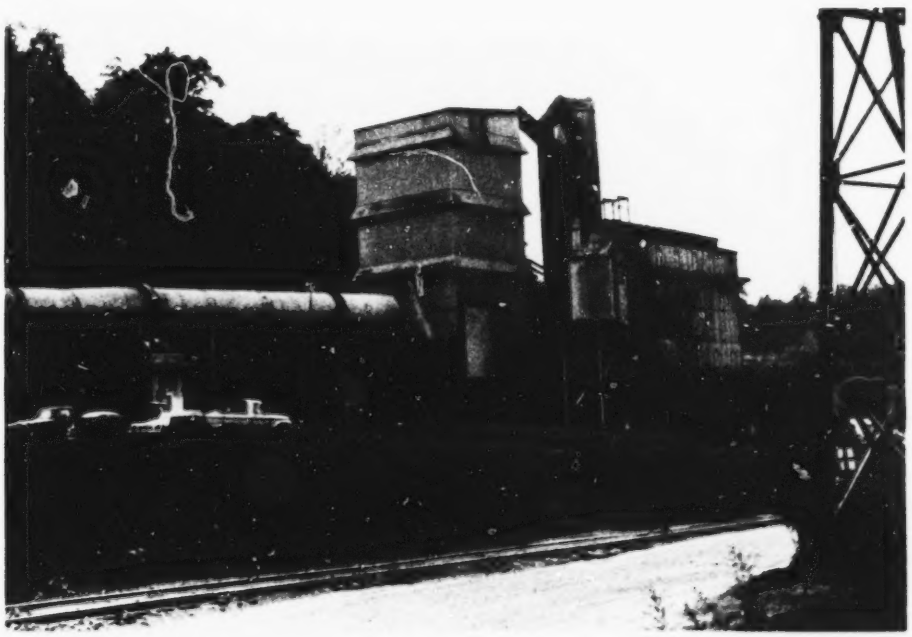
Exhaust gases from the kiln pass first through a set of multiclones for removal of large particulates, then through a set of four radiant cooling loops, and finally through the fabric filter (Figure A9-1). The old stack (available for emergency bypass) and the system fan are between the cooling loops and the filter. The cooling loops reduce filter inlet gas temperatures to between 230° and 260°C.

Figure A9-1. View of Source 9 with rotary kiln on the left, fabric filter on the right, radiant cooling in the center, and emergency bypass stack (partially obscured) behind the cooling loops.

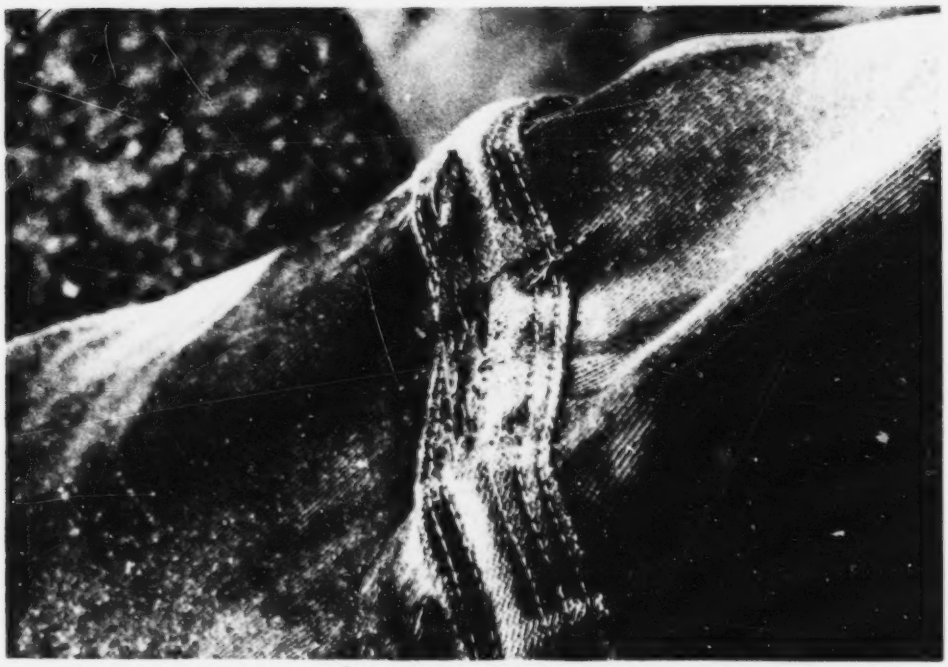
Figure A9-2. Filter bag showing tear caused by abrasion with corroded, mild steel support ring.

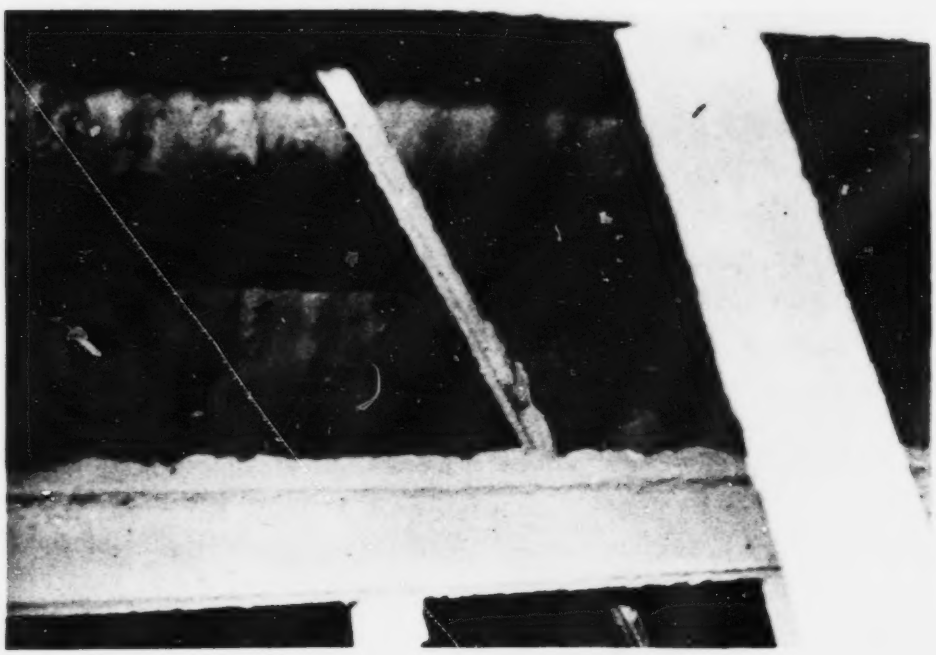
The structural steel showed signs of corrosion during the inspection, but there have been no structural failures to date. The corrosion was most apparent near the roof exhaust (Figure A9-3) and near the access doors where heat losses and condensation are most likely (Figure A9-4). In general, the structural

Figure A9-3. Structured steel near filter showing corrosion of the roof support beam.

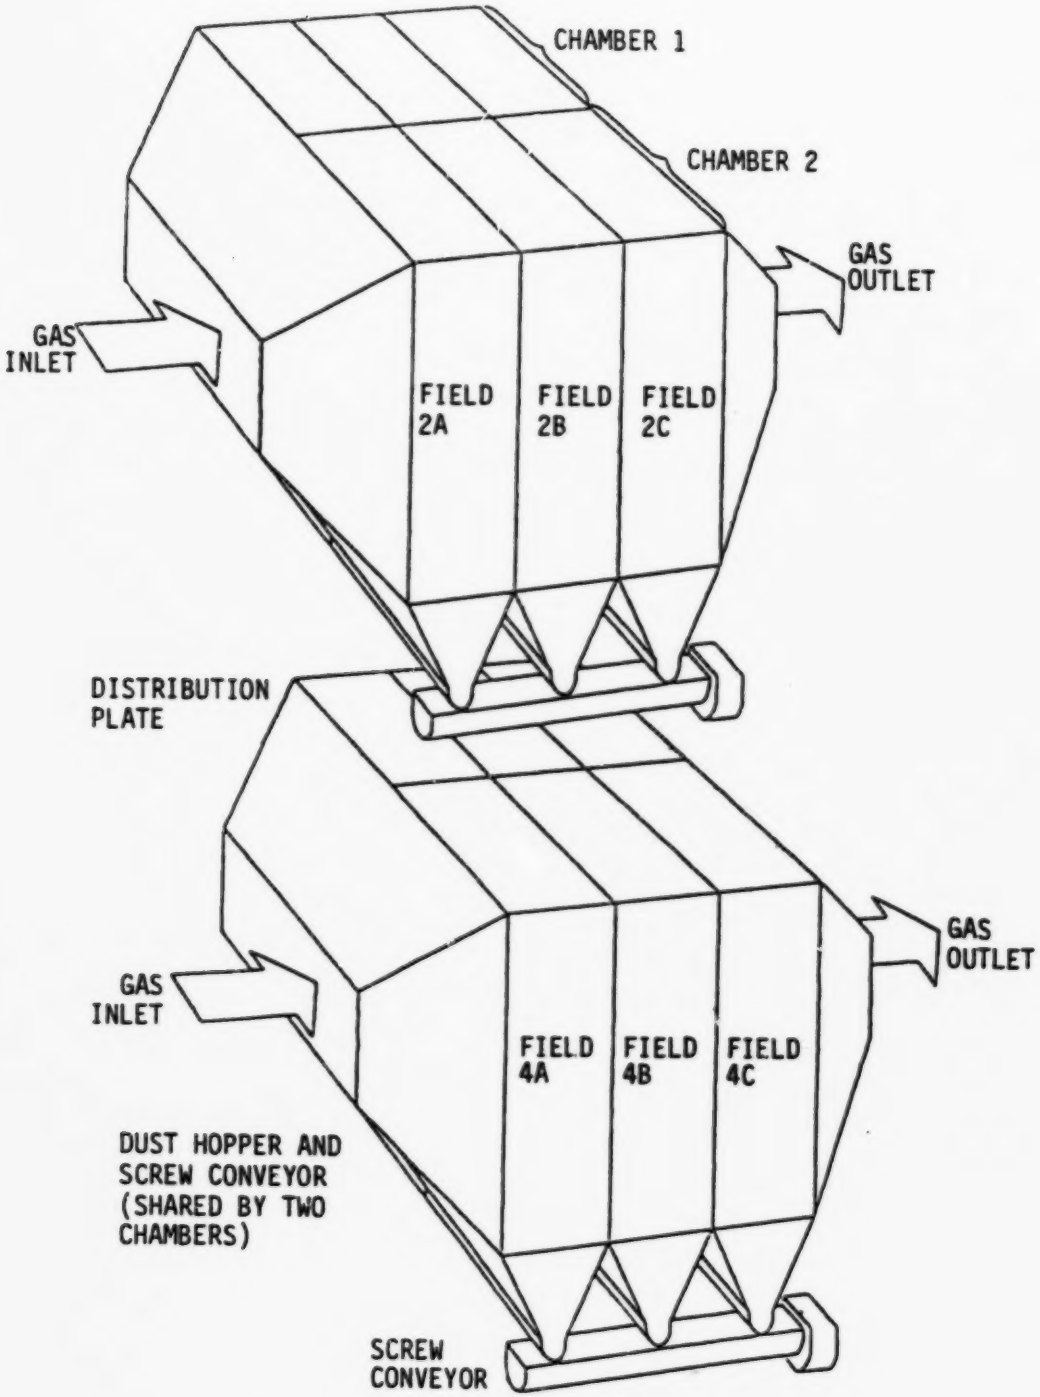
Figure A10-1. General arrangement of Source 10 ESP.

The first corrosion-related malfunctions were in the secondary circuit insulator compartments. The casings of the

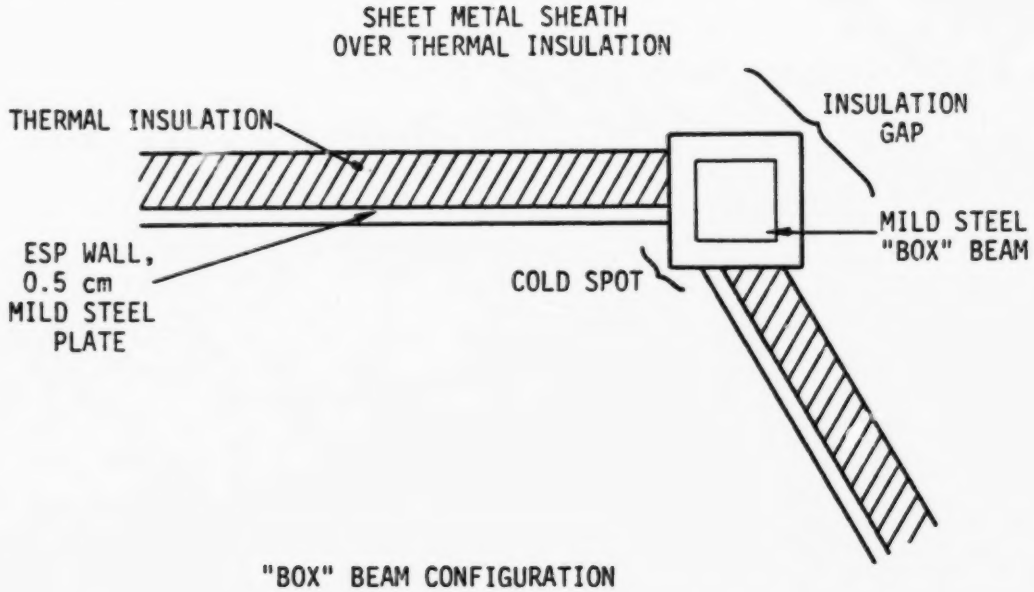
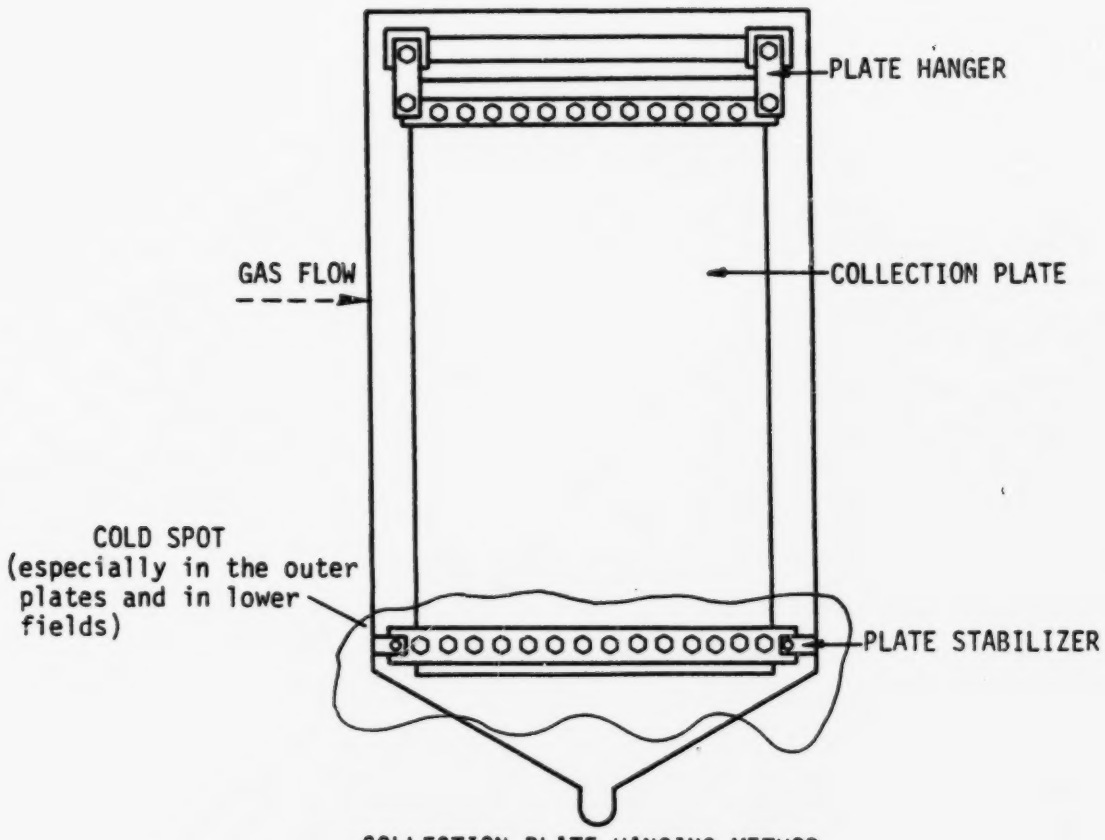
Figure A10-2. Locations of cold spots within the Source 10 ESP.

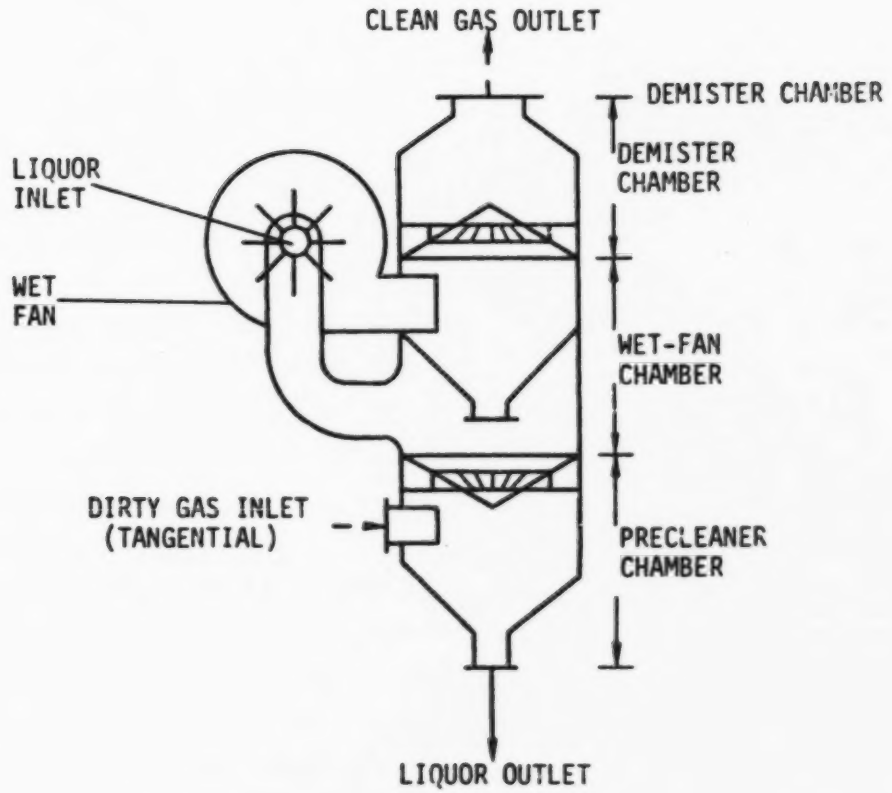
Figure A15-1. Source 15 wet-fan scrubber.

Source 15 consists of three coal-fired rotary lime kilns located at a limestone quarry. Each kiln has two wet-fan scrubbers, arranged in parallel, for removing particulate from kiln exhausts (Figure A15-1). In the two larger kilns, the scrubber pairs are used simultaneously, while in the smallest kiln, the scrubbers are alternated.

Each scrubber contains three chambers: a tangential inlet, cyclonic precleaner chamber at the bottom of the vessel; a wet-fan chamber in the middle; and a centrifugal mist eliminator at the top. All scrubber vessel parts are carbon steel. The fan wheel is type 304 stainless steel and the fan housing is carbon steel. The scrubber stacks were originally carbon steel, but they are being replaced with type 304 stainless steel stacks.

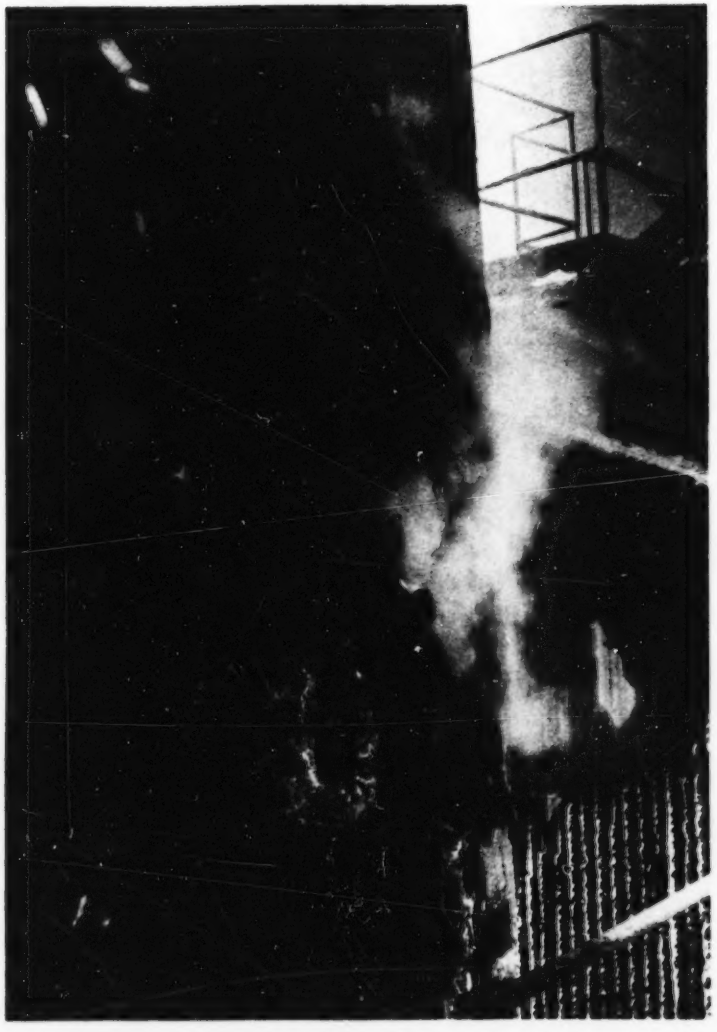
Figure A15-3. Entry hatch of a scrubber vessel showing leaks resulting from lime deposits and corrosion at the seal.

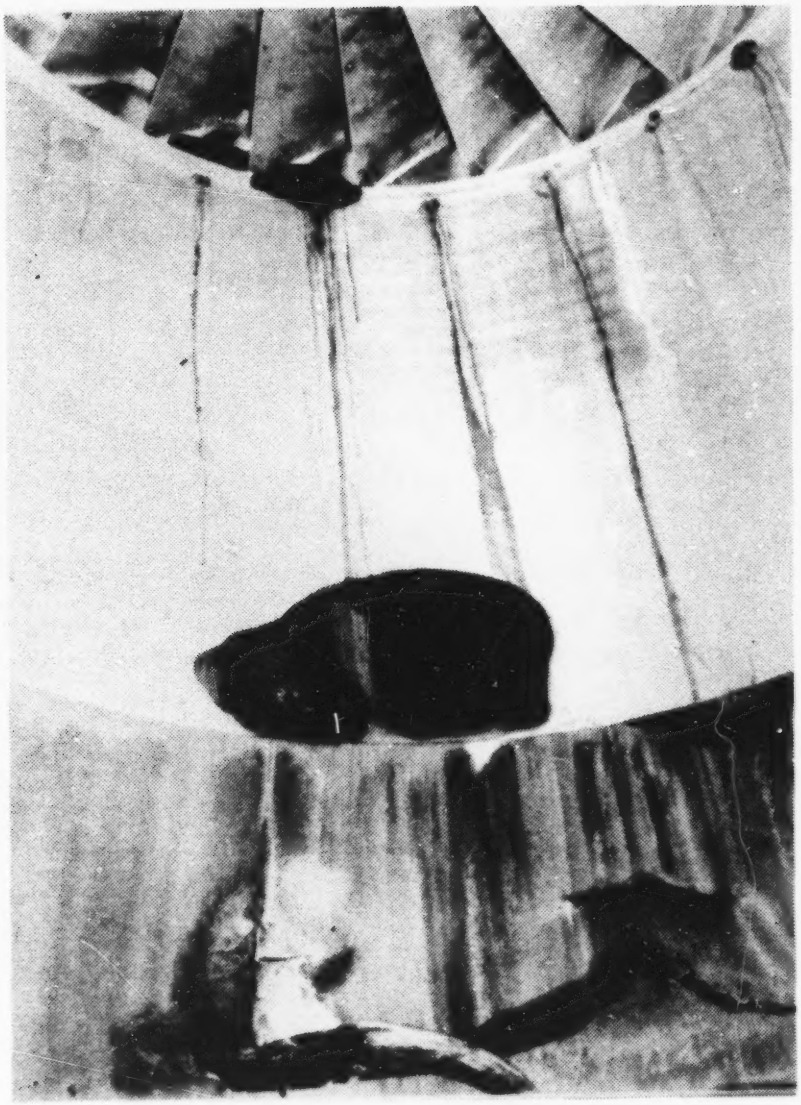
Figure A17-1. Inside of Source 17 scrubber vessel showing (from top to bottom) corrosion of 304 stainless steel rotating vanes, vessel wall, and venturi skirt after only 2 months service.

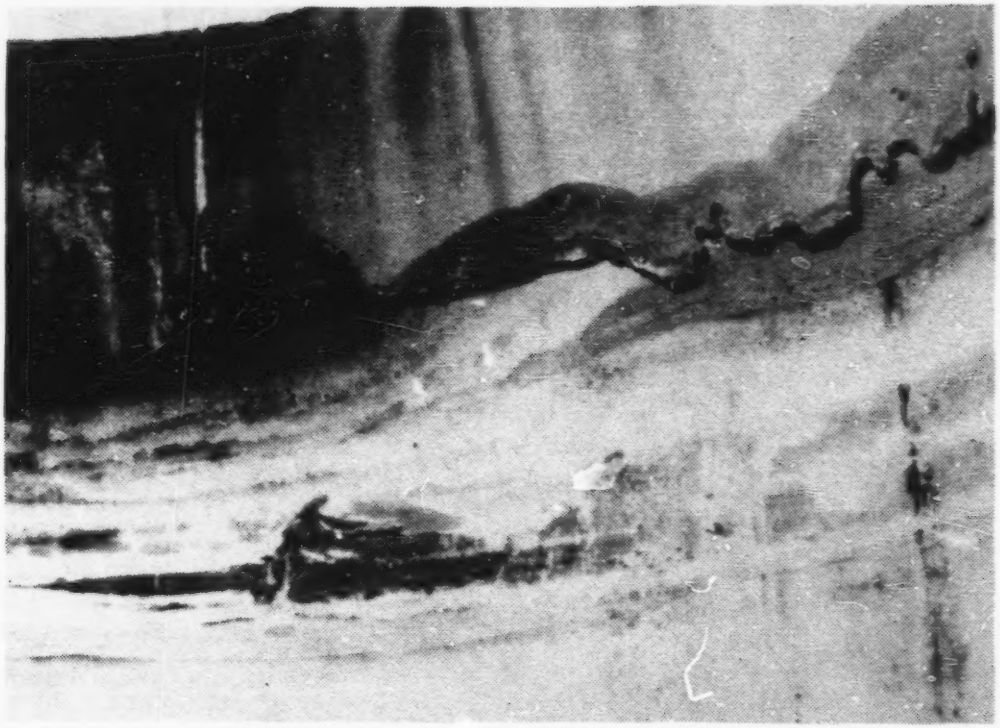
Figure A17-2. Inside of Source 17 scrubbing vessel showing corrosion of 304 stainless steel venturi skirt after only 2 months service.
